### INCIDENT NOTICE

**INCIDENT TITLE:** 10 Mar 2021: Finland – sinking of a MEMU-truck

| DATE POSTED | REFERENCE | SOURCE |
|---|--|---|
| 6 May 2021 | IN 21-14 | Non-Member |

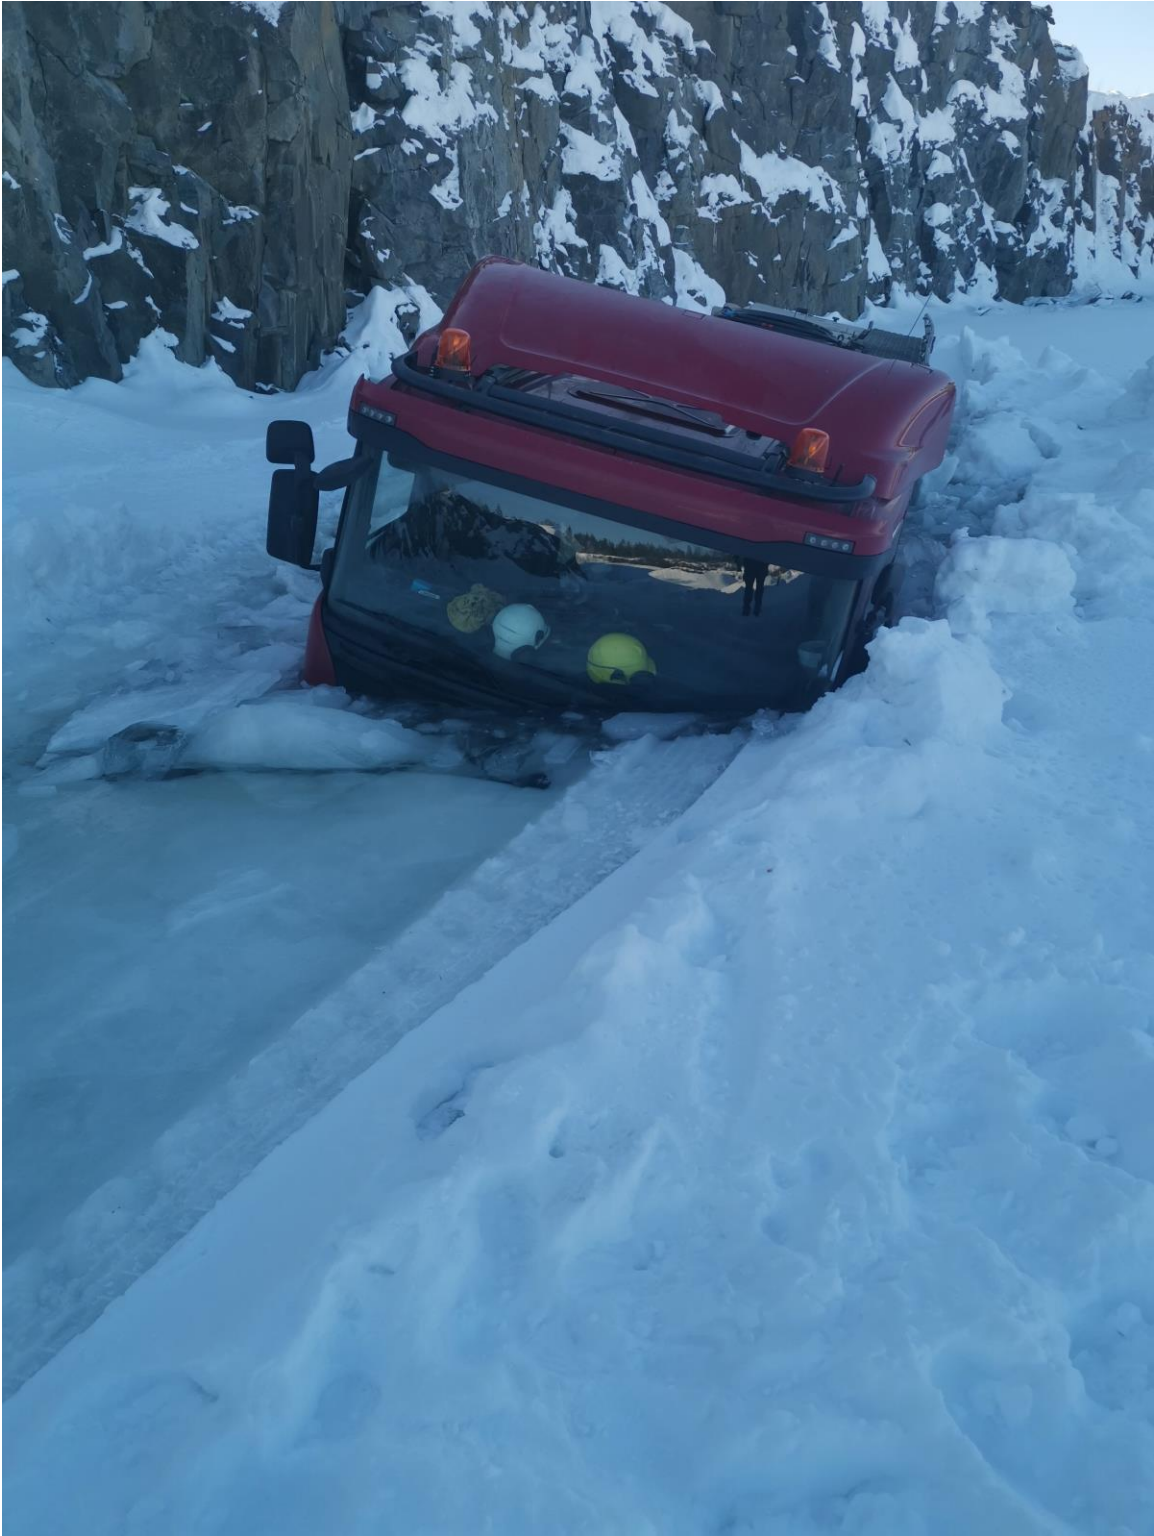
| DATE POSTED | REFERENCE | SOURCE |
|---|--|---|
| <b>What happened?</b> | At the beginning of a loading operation the MEMU-truck fell through ice and was immersed in water about 2 meters deep | |
| <b>Why did it happen – theory?</b> | The operators were instructed to drive to a road leading to the pumping site, the road was ploughed through snow and over ice that had formed over a pit of water. The road was apparently ploughed to a wrong location. The part of the road which went over ice was not marked in any way. | |
| <b>What was the impact?</b> | No injuries to personnel. The MEMU-truck was badly damaged due to water ingress of drivetrain and electrical control systems.<br><br>The tanks of the MEMU remained intact and nothing leaked to the environment | |

**MEMU in the water**

Clients are recommended to provide a clear description of driving arrangements on worksites. Operator training to include escape training in case of truck sinking. Emergency hammers in the cabin.

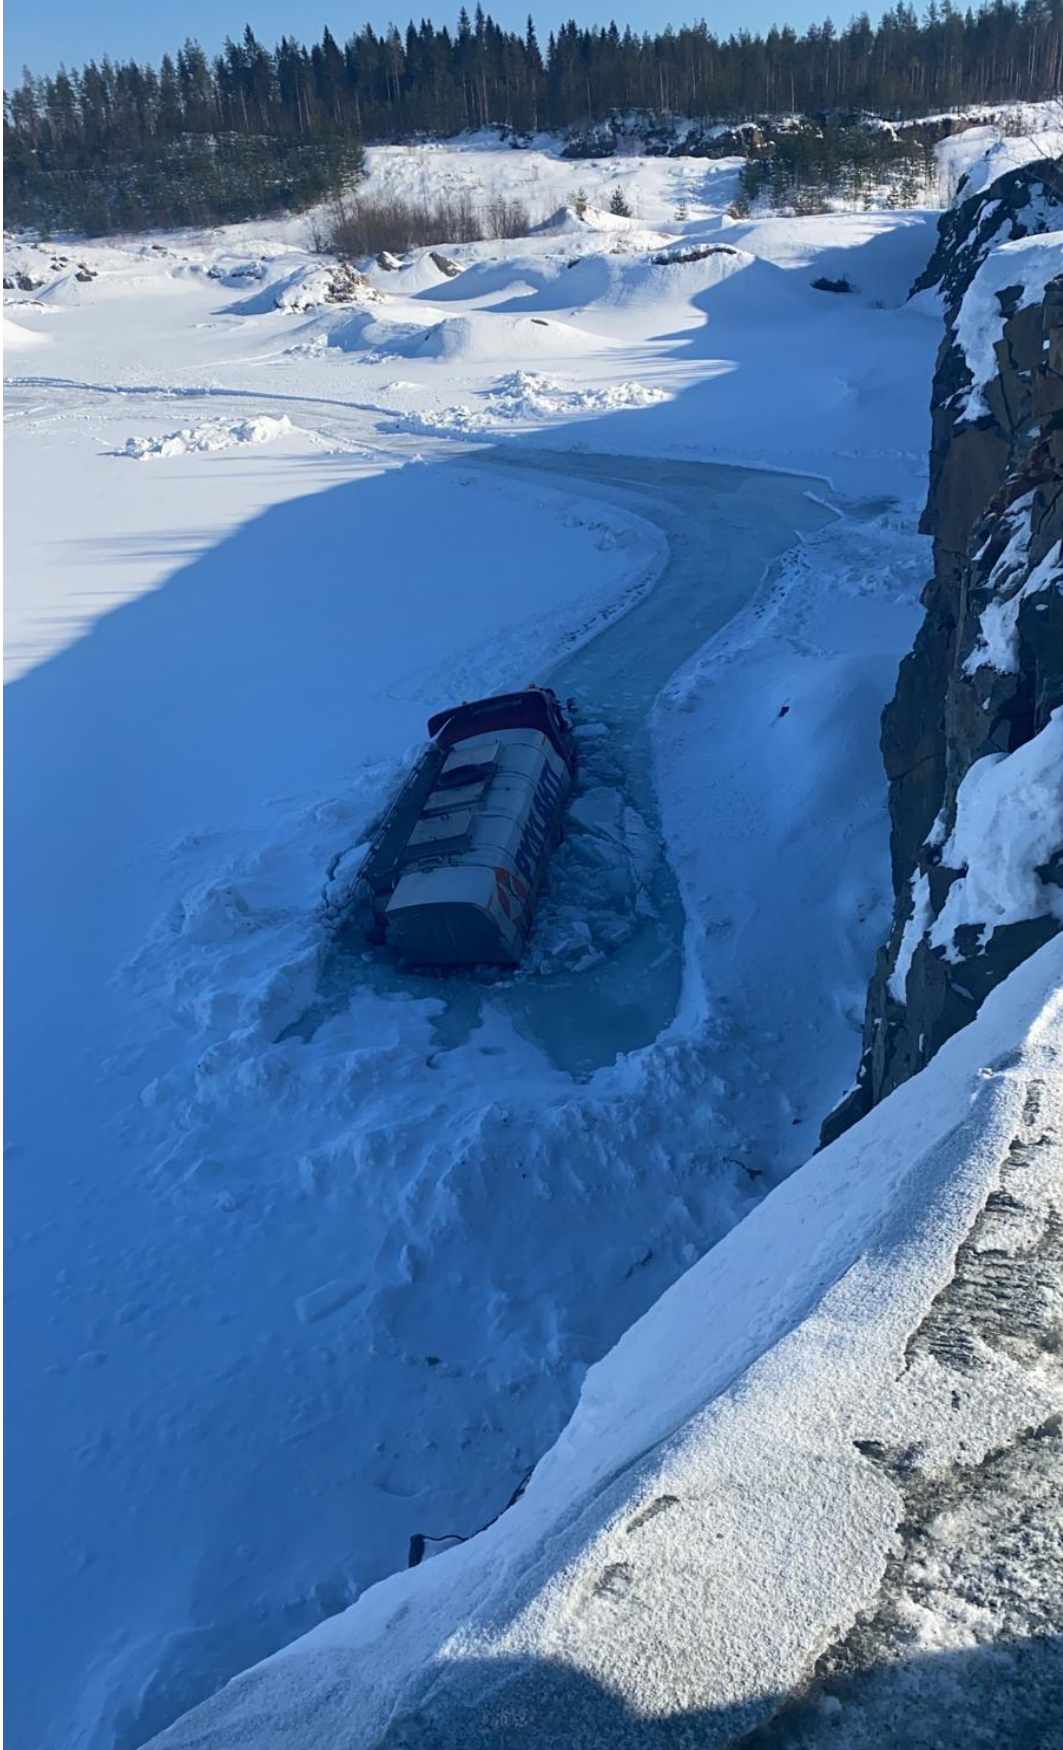
**MEMU in the water**

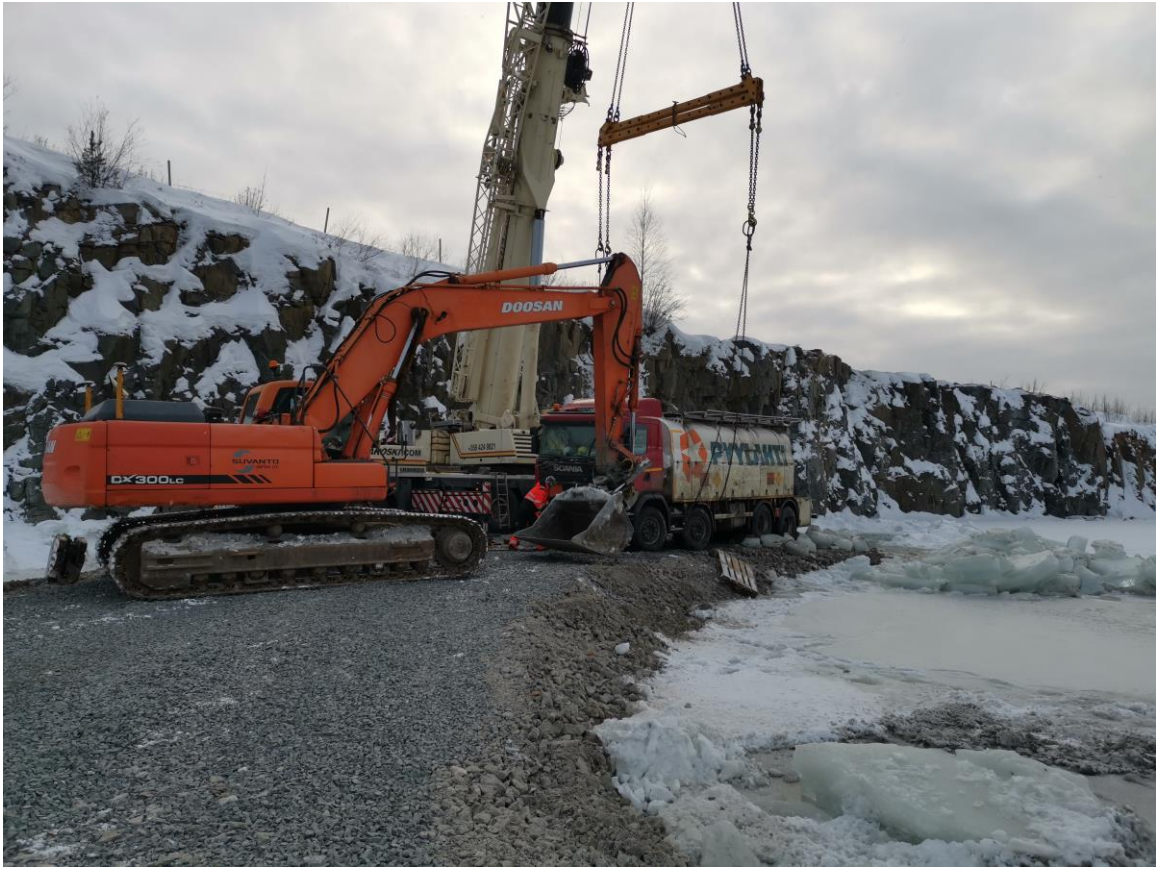
**Lifting operation done**

By draining the oil and water from the drivetrain of the truck almost immediately after the lifting was done and by filling the drivetrain back with oil, drivetrain damage was kept to a minimum. Ingressed water could not freeze and break the block and new oil prevented corrosion.
