# INVESTIGATION INFORMATION RELEASE

## Person at risk from flyrock at quarry

Event: Dangerous blasting incident at a hard rock quarry

Location: Cootamundra Quarry, Cootamundra NSW

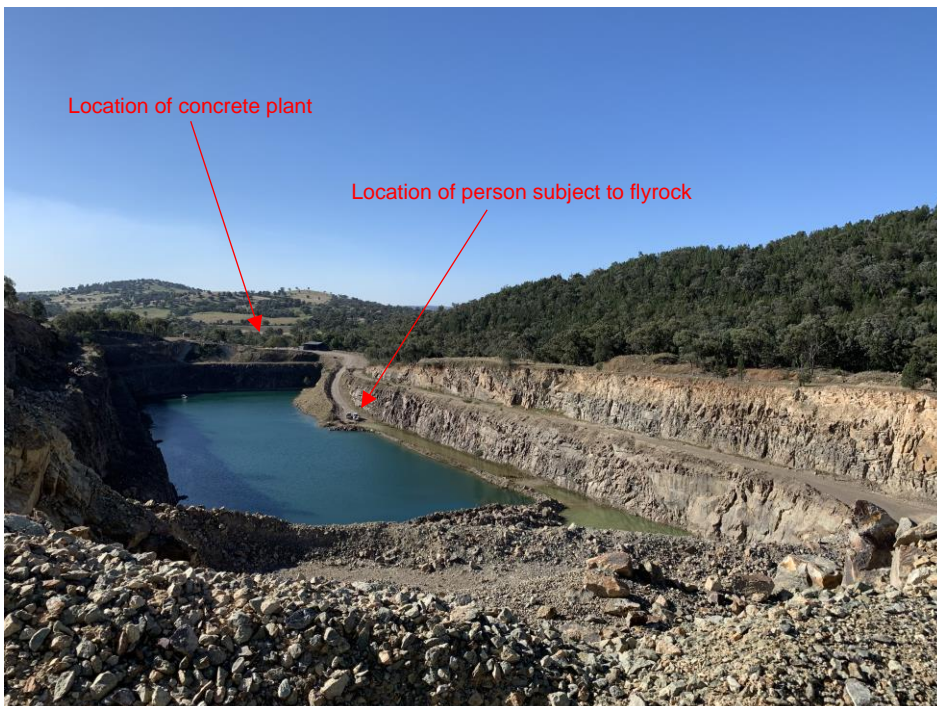
*Figure 1: View looking north from area adjacent to blast showing location of person within blast exclusion zone*

At about 2:15pm, while filling the agitator, the Tegra worker felt a rush of air and sheltered behind the truck for protection as the blast was initiated and flyrock landed around him. When the flyrock stopped falling the worker turned off the pump and drove the truck out of the quarry to the concrete plant and Milbrae office where he reported the incident.

The Tegra worker was approximately 347 metres from the blast when the shot was fired.

- their explosives control plan is reviewed to verify that it adequately identifies and controls specific risks associated with the use of explosives at their sites
- the shotfirer-in-charge designs and loads a shot with sufficient burden, spacing and stemming to prevent flyrock and other dangerous effects
- blast areas remain clear until the blast has been fired and the “all clear” has been given by the person firing the blast
- security arrangements associated with blasts are adequate to identify any person that may unwittingly enter the exclusion zone
- processes are in place to control the risk of injury or death if the exclusion zone is breached
- the safety of all persons in a blasting area.
