**Explosives Inspectorate  
Resources Safety & Health  
Queensland****ALERT | ALERT | ALERT | ALERT | ALERT****Explosives Inspectorate | Alert | No.103 V 1 | 08 September 2021**

# **Ignition of fuel-air mixture from mobile processing unit discharge auger**

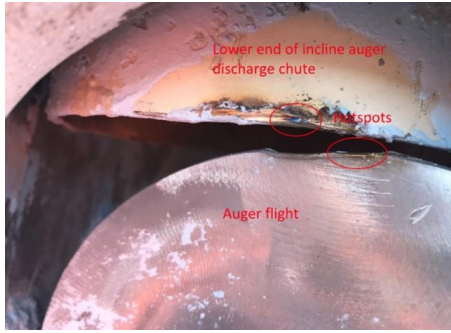
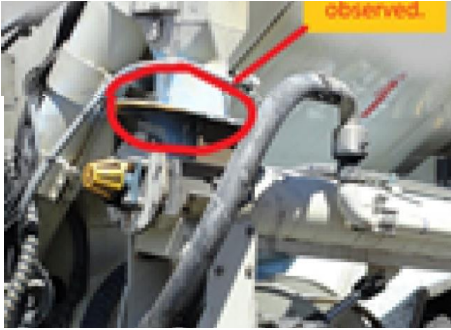
It was identified that the incline auger chute had contacted a discharge auger flite. The resulting friction created a hot surface with the level of heat produced by the friction in the order of  $>300^{\circ}\text{C}$ . The presence of a fuel oil (diesel), air mixture in the immediate area of the hot spot led to an ignition event.

The investigation identified that the lack of auger engineering design tolerances was a contributing factor combined with inadequate critical control maintenance of the augers. This resulted in metal-to-metal contact between the first flight of the discharge auger and the lower end of the incline auger transfer chute.

1. Review MPU Hazard and Operability (HAZOP) studies to ensure design specifications provide adequate component spacing to eliminate metal to metal contact.
2. Inspect existing MPU fleet critical safety components to ensure operating tolerances are within specifications where metal-to-metal contact can occur.
3. Review, and update as necessary, maintenance and inspection procedures for MPU's for critical safety components for MPU operations.
